RCC Panel 6 Foam Impact Test Results (Preliminary)

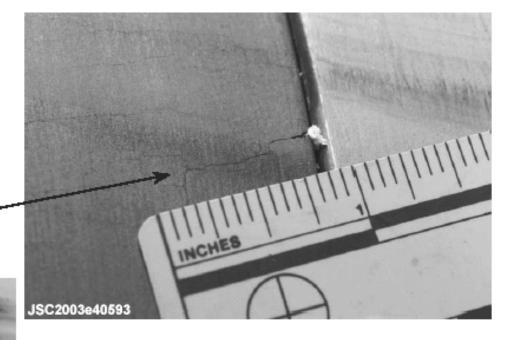
RCC Panel 6 Impact Test Results

- 5 1/2" long through-thickness crack
- Located on the lock side approximately 6" below the stagnation line (apex)
- Transverses the entire rib width, extends through the lock side channel and onto the panel lower face
- Approximately 3/4" crack on the lower face

- Projectile ink streaks start on RCC panel 6, continue across T-Seal 6 and onto the fiberglass panel 7.
- Foam debris was caught between RCC panel 6 and T-Seal 6.

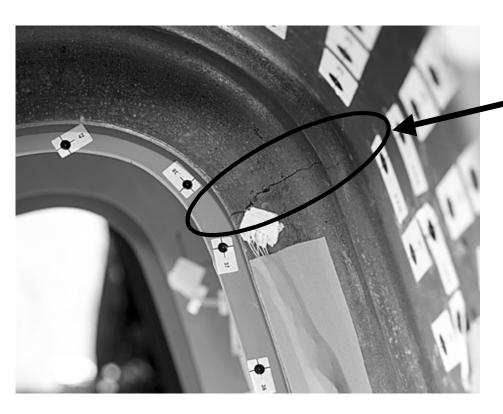
RCC Panel 6 Impact Test Results

- Visible crack in panel rib, ~ 5" in length emanating from the surface; crack also found in adjacent T-Seal
- Visible as a 3/4" surface crack, ~4" below the apex of the panel
- Easily detectable with routine inspection techniques
- Panel 6 has been removed and will be inspected using a variety of inspection techniques to further characterize the crack

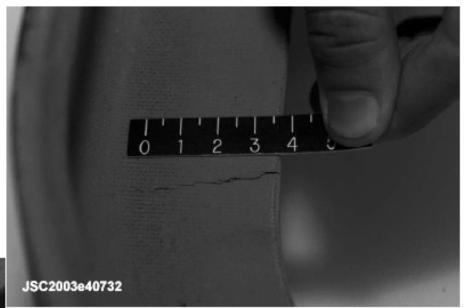
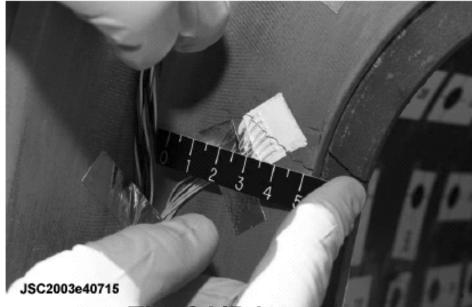
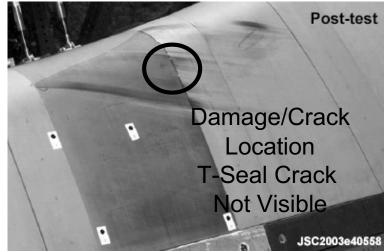
T-Seal Crack Adjacent to Panel 6 Rib Crack

- The T-Seal crack is approximately 6" below the stagnation (near the panel crack)
- Approximately 2 1/2" through crack on the RCC T-Seal 6 lower outboard rib
- Crack starts at rib and continues into filets
